Survey of pedestrian infrastructure at signalled intersections in Pune

Study conducted in July 2020

Report by
Harshad Abhyankar (harshad.abhyankar@savepunetraffic.org)

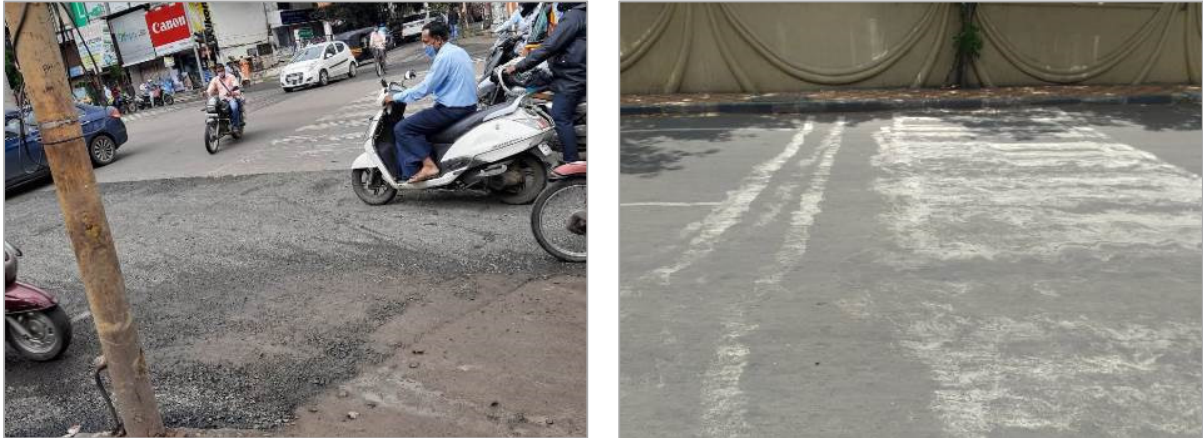
1. Perfect: Bright zebra and stop line.
2. Just ok. Might need paint in a few weeks.
3. Too faint or no zebra / stop line.

Figure 3: Bad or missing markings (left, 0 points), just OK markings (right, 1 point)

1. PMC Road Department and Ward offices should continue painting and maintaining the zebra and stop line markings, improving their score continuously.
2. Pune Traffic Police should promptly report malfunctioning pedestrian signals to PMC.

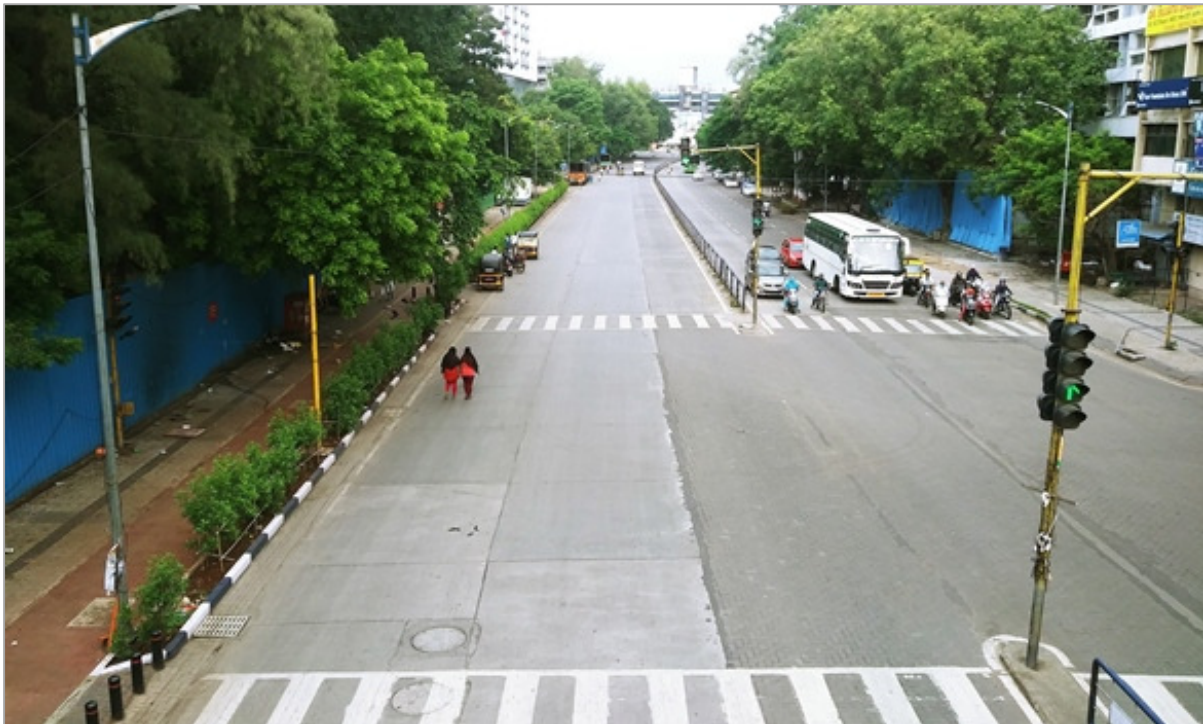
Figure 4: Good markings (2 points)

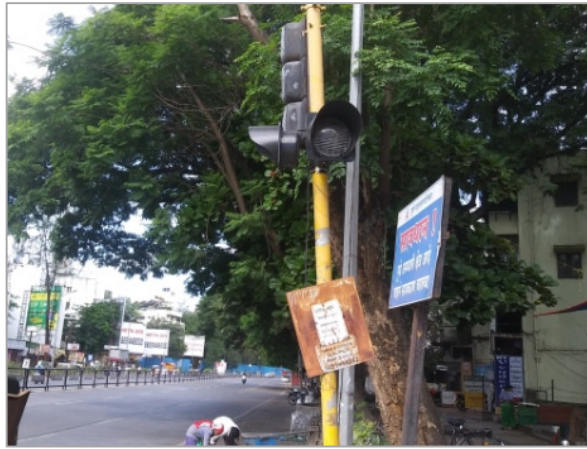
The condition of the pedestrian signals needs substantial improvement.

1. Only about 6% pedestrian signal lights were working. This shows a complete lack of concern for pedestrians' safety on part of the Traffic Police as well as PMC's Electrical Department and their contractors. If Traffic Police cared about pedestrians' safety, they would lodge complaints for missing pedestrian signal aspects. Likewise, if PMC personnel and their contractors cared about pedestrians' safety, they would notice and repair these signals whenever they repaired any vehicular signals in the same chowk.
2. On an average, signals in Pune provide about 56% of the time required for people to cross the roads safely. For information, SPTM's efforts in 2010-12 timeframe have contributed to this number being at least this high. Historically, increasing the timing of pedestrian phase had generally been resisted by Traffic Police in those days and we hope the situation has changed.

Figure 5: Non-functional pedestrian signal

3. PMC Electrical Department should also proactively repair failed pedestrian signal aspects.
4. PMC Electrical Department should ensure that the signals are programmed to provide at least the minimum pedestrian phase duration, derived using formulas provided in IRC:93. They must do this regardless of any opinion to the contrary, whether by general public or Traffic Police or any other entity.

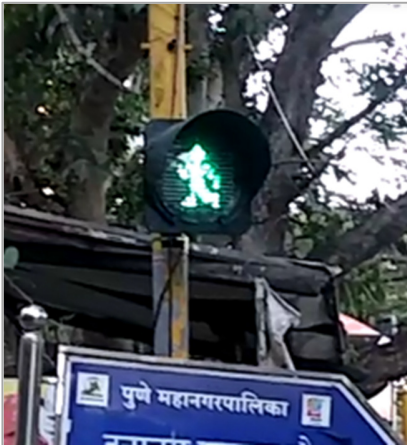
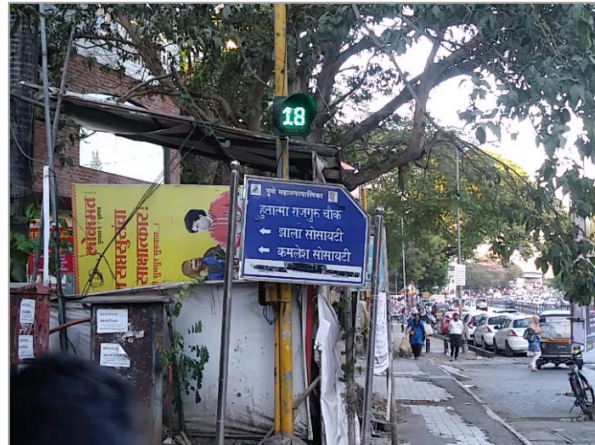
4. A mechanism that tells a pedestrian whether it is safe to start crossing now: As a pedestrian starts to cross a road even when the pedestrian signal is green, s/he needs to know how many seconds remain before vehicles get a green. This can be achieved by installing pedestrian signals with timers. Alternatively, the signals should be programmed in such a way that even as the red pedestrian signal starts blinking, vehicles will not get a green signals for a duration prescribed by IRC:93. This will ensure that a pedestrian who has started crossing the road as the steady green turns blinking red, will be able to cross the road safely.

Figure 6: Working pedestrian signal (left), with timer for pedestrians (right)

5. In spite of the above, pedestrians will need some indication to tell them whether it is safe to start crossing the road at a given instant. PMC should invest in pedestrian signals with timer, which seems to be the best among the available options. If required, the signal controllers would have to be changed to provide such indication.
